Inspection Report

Subject: McDonough County Heritage Farms Dairy
(Bushnell) Reconnaissance Inspection

Date: December 18, 2012

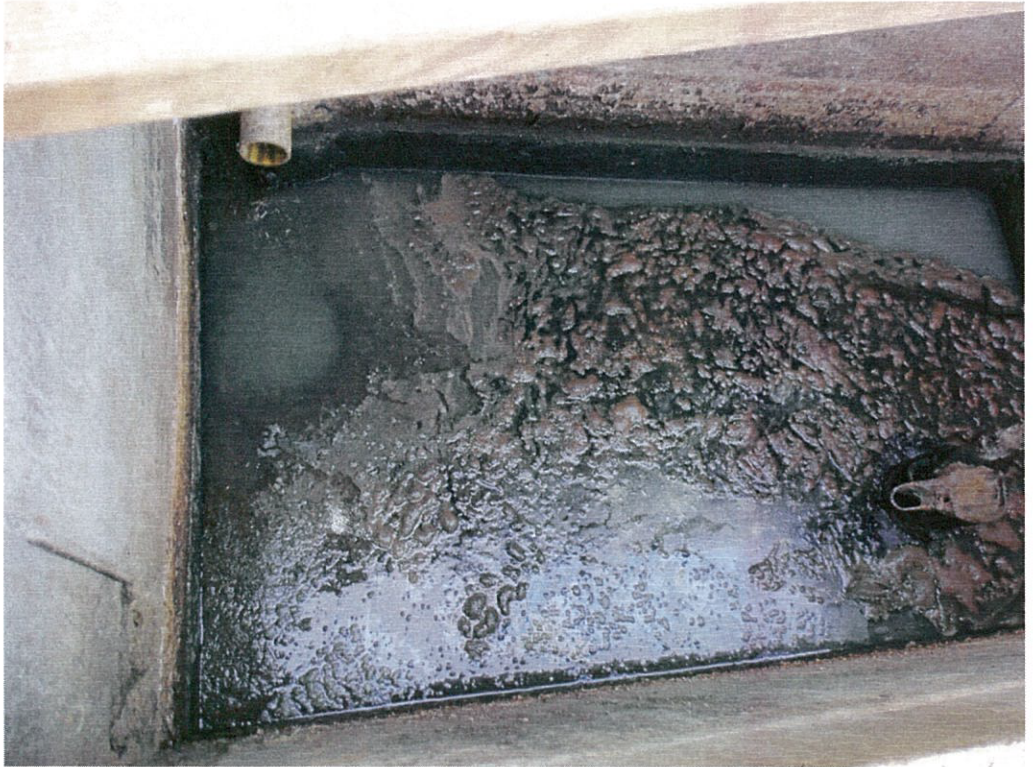
The approximately 4" diameter pvc pipe that previously was installed in the milking parlor concrete pit and was connected to a tile line has now been permanently removed from the pit. The location where the pipe was in the concrete pit has been sealed and the tile line has been diverted around the pit. This pit is shown in Photographs #1-4, the sealed areas are shown.

County: McDonough	
Comments: Inside the milking parlor concrete pit.	
Photo #: 2 Photo Title:

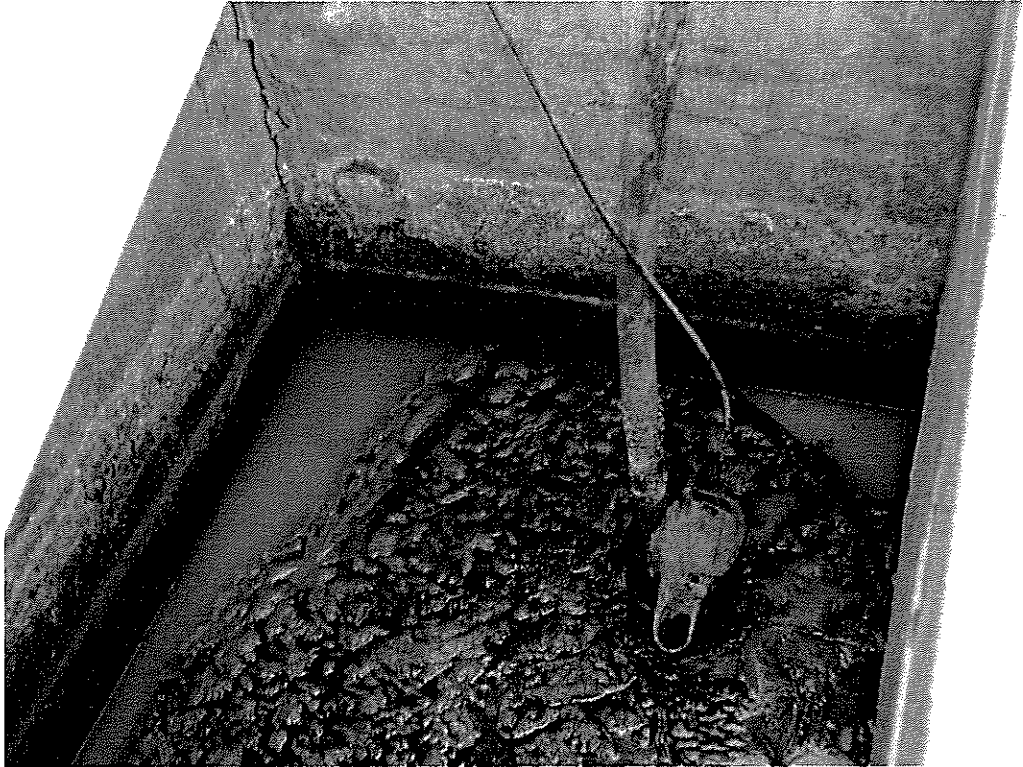
County: McDonough	
Comments: Submersible pump inside the milking parlor concrete pit. Concrete is sealed where pvc pipe to tile discharge was located.	
Photo #: 3 Photo Title:

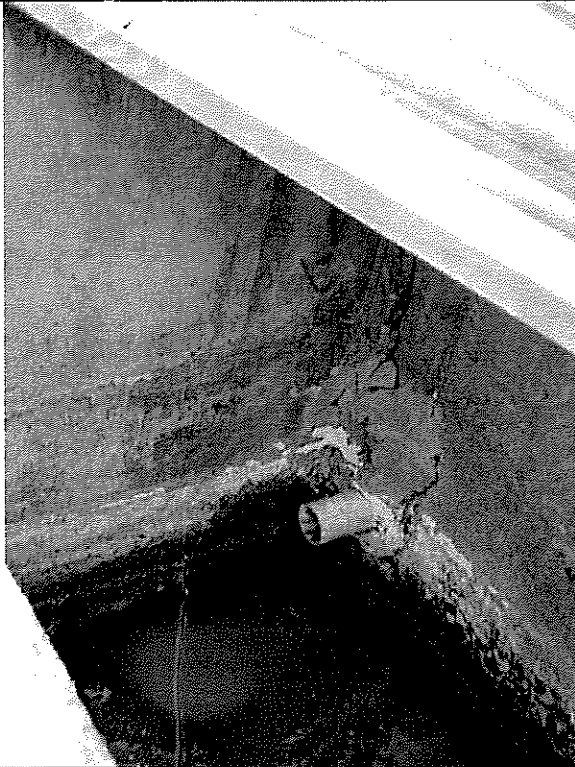
County: McDonough	
Comments: Concrete is sealed where pvc pipe to tile discharge was located.	
Photo #: 4 Photo Title:

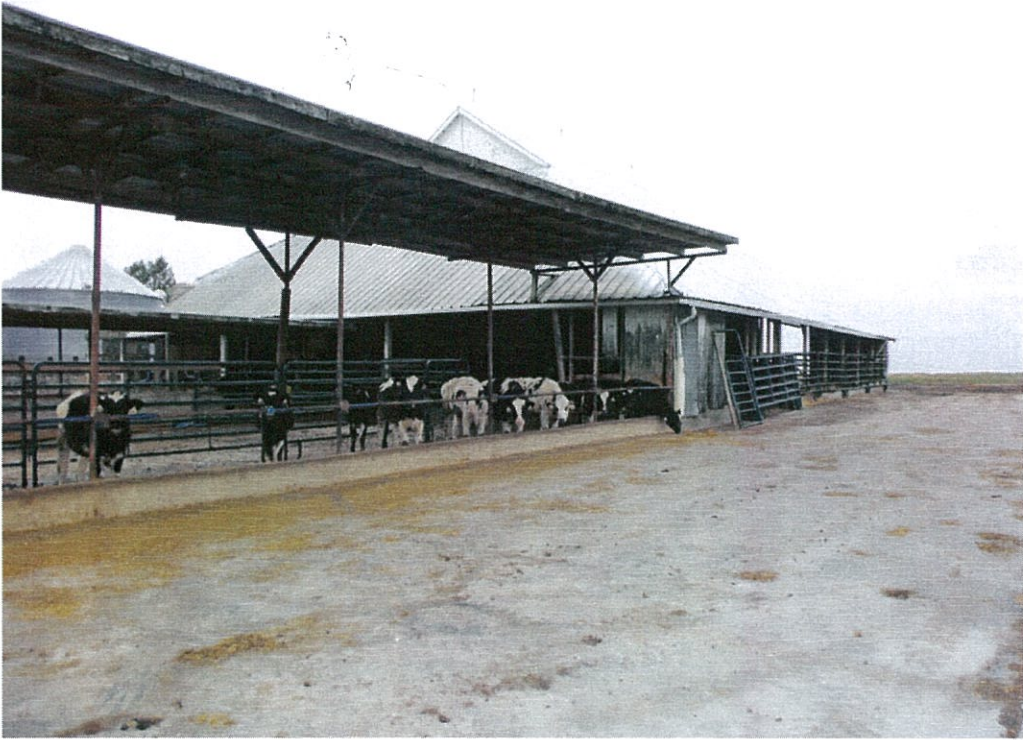
County: McDonough	
Comments: East side of the north barn, view is northwest. Cattle are being kept under roof.	
Photo #: 5 Photo Title:

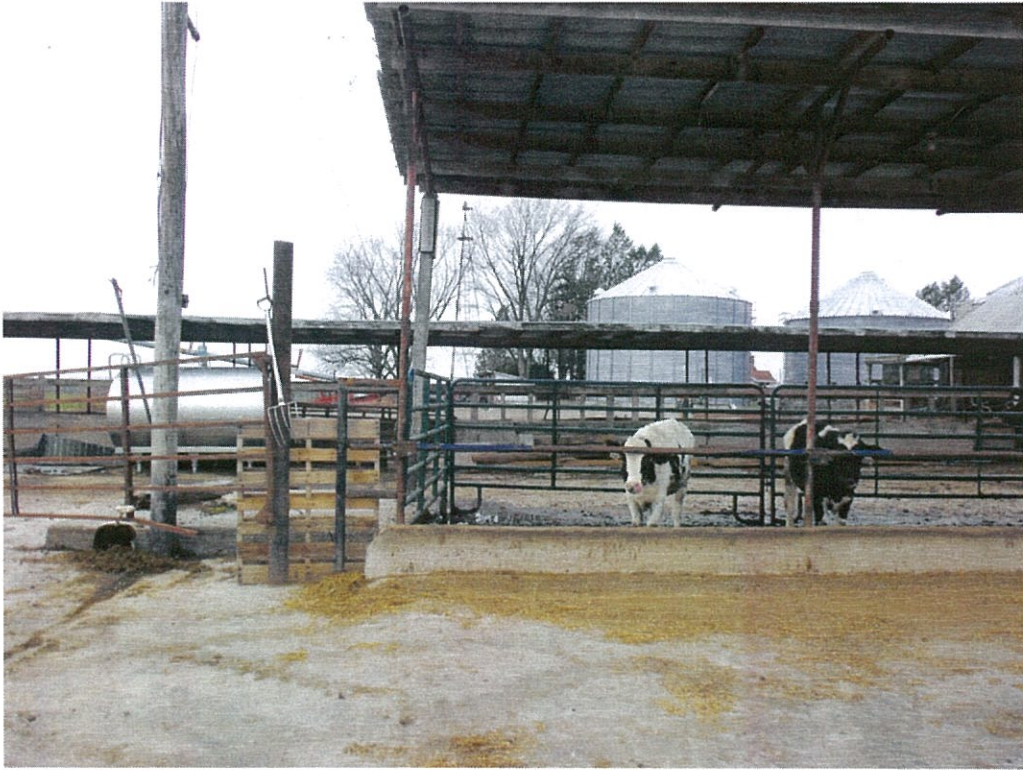
County: McDonough	
Comments: South side of the north barn, view is west.	
Photo #: 6 Photo Title:

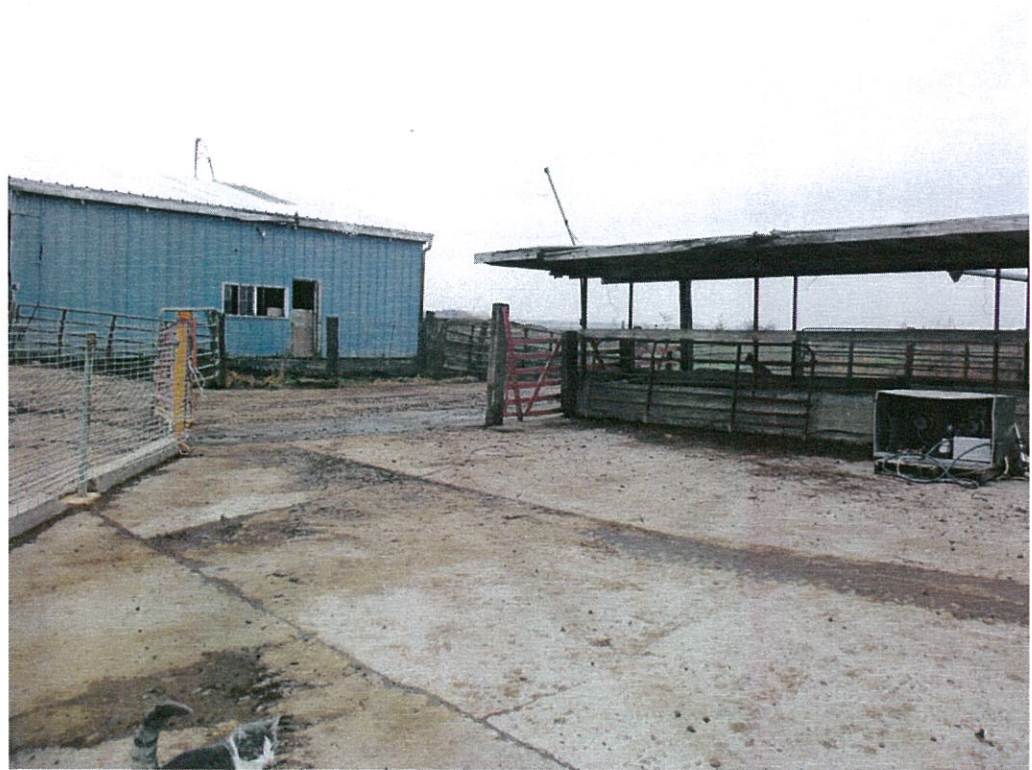
County: McDonough	
Comments: Transfer lanes shown to the east of the north barn, view is southwest.	
Photo #: 8	
Photo Title:

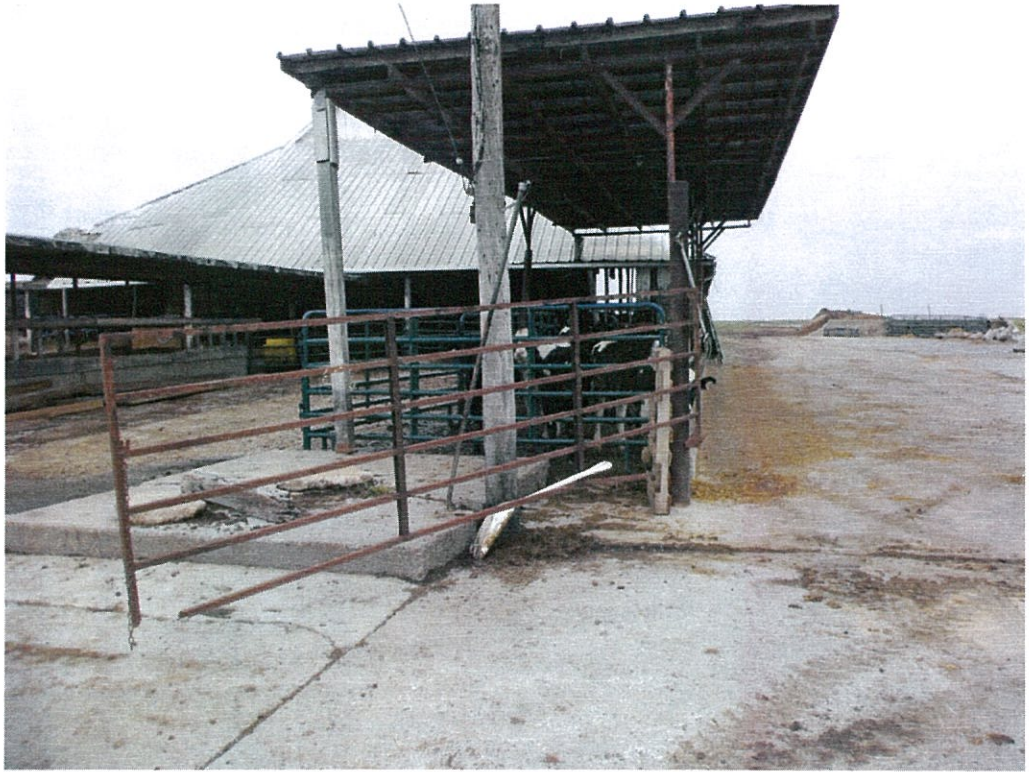
County: McDonough	
Comments: North barn, view is north.	
Photo #: 9	
Photo Title:

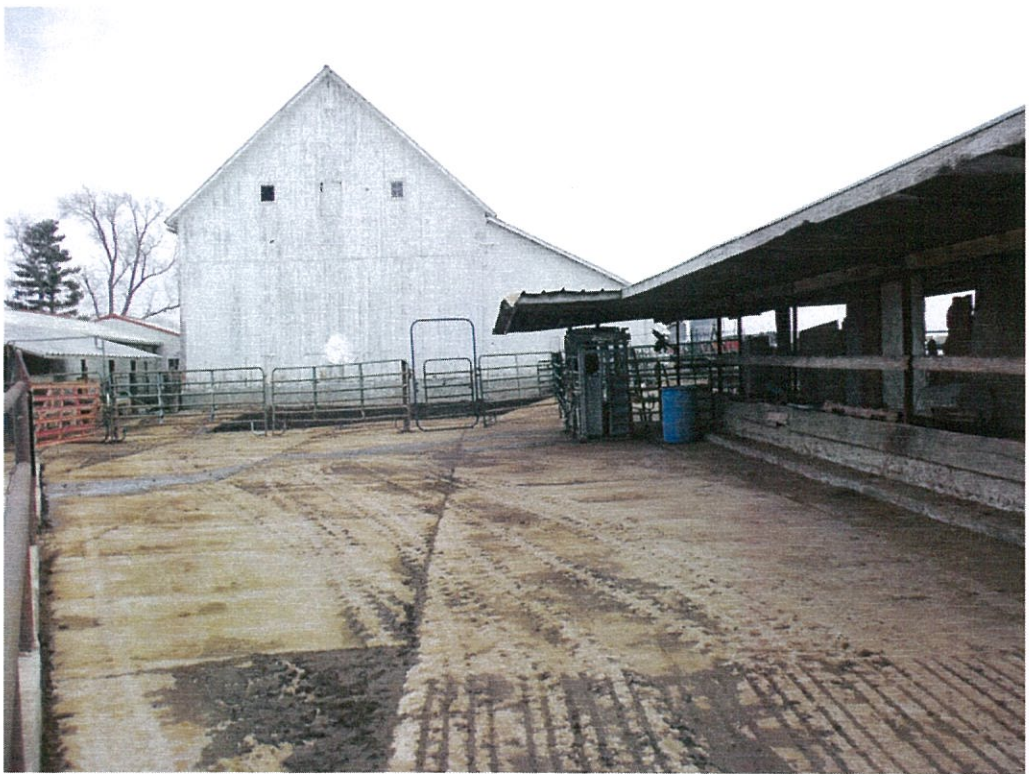
County: McDonough	
Comments: Horse barn feedlot, view is east.	
Photo #: 10	
Photo Title:

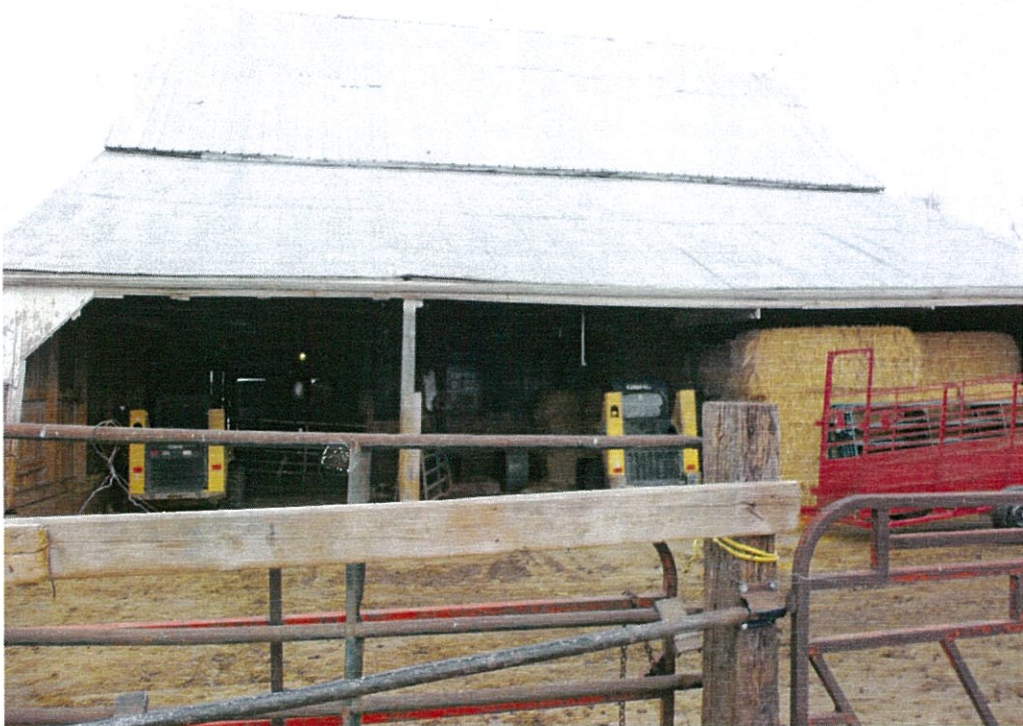
County: McDonough	
Comments: South side of horse barn, view is north.	
Photo #: 11 Photo Title:
